## Physical-chemical Characterization of Black Crusts Coming from Cagliari Town Hall, "Palazzo Bacaredda", Cagliari (Italy)

Cagliari Town Hall (1899) known as "Palazzo Bacaredda" has been studied and restored many times from its building. Subsequently, the finding of black crusts on the plaster layer suggested us to identify the cause of their formation and analyze their crystal structure and composition in order to propose some strategies for their removal during the incoming restoration intervention.

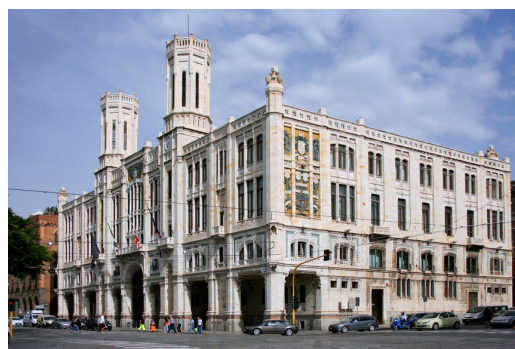
Fig. 1; The façade and south side of Cagliari Town Hall "Palazzo Bacaredda", Cagliari,

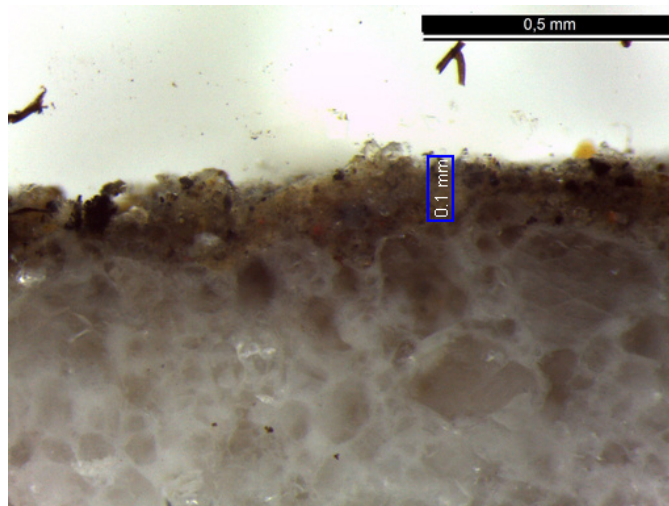
The images obtained by the optical microscope (see Fig.2) highlight the microstructure of the sample and the presence of black crusts on the layer exposed to the external environment. The SEM gives better images of the sample's microstructure and the EDS analyses allow to identify its elemental composition (see Tab.1). Data in Table 1 evidence that the main component of both the sample and the black layer is calcium carbonate and the low concentration of sulfur, that can be attributed to the presence of gypsum, let to state that the sulfation occurred at a very low extent. On such base, we can assume that the black

Fig. 2; Macro photo of a polished section of a plaster sample

crusts are the product of the re-crystallization of calcite, leached by acidic rain, which has incorporated black carbon particles (C), terrigenous silico alluminate (Si and Al) and also some iron particles.
