# Chemical-physical diagnostics propaedeutic to the conservative restoration of the Funus Cippus of Quinto Cornelio Procliano

Emanuele Dell'Aglio<sup>1\*</sup>, Maria Luisa Astolfi<sup>1</sup>, Maria Pia Sammartino<sup>1</sup>, Marco Castracane<sup>2</sup>, Giovanni Visco<sup>1</sup>, Luigi Campanella<sup>1</sup>

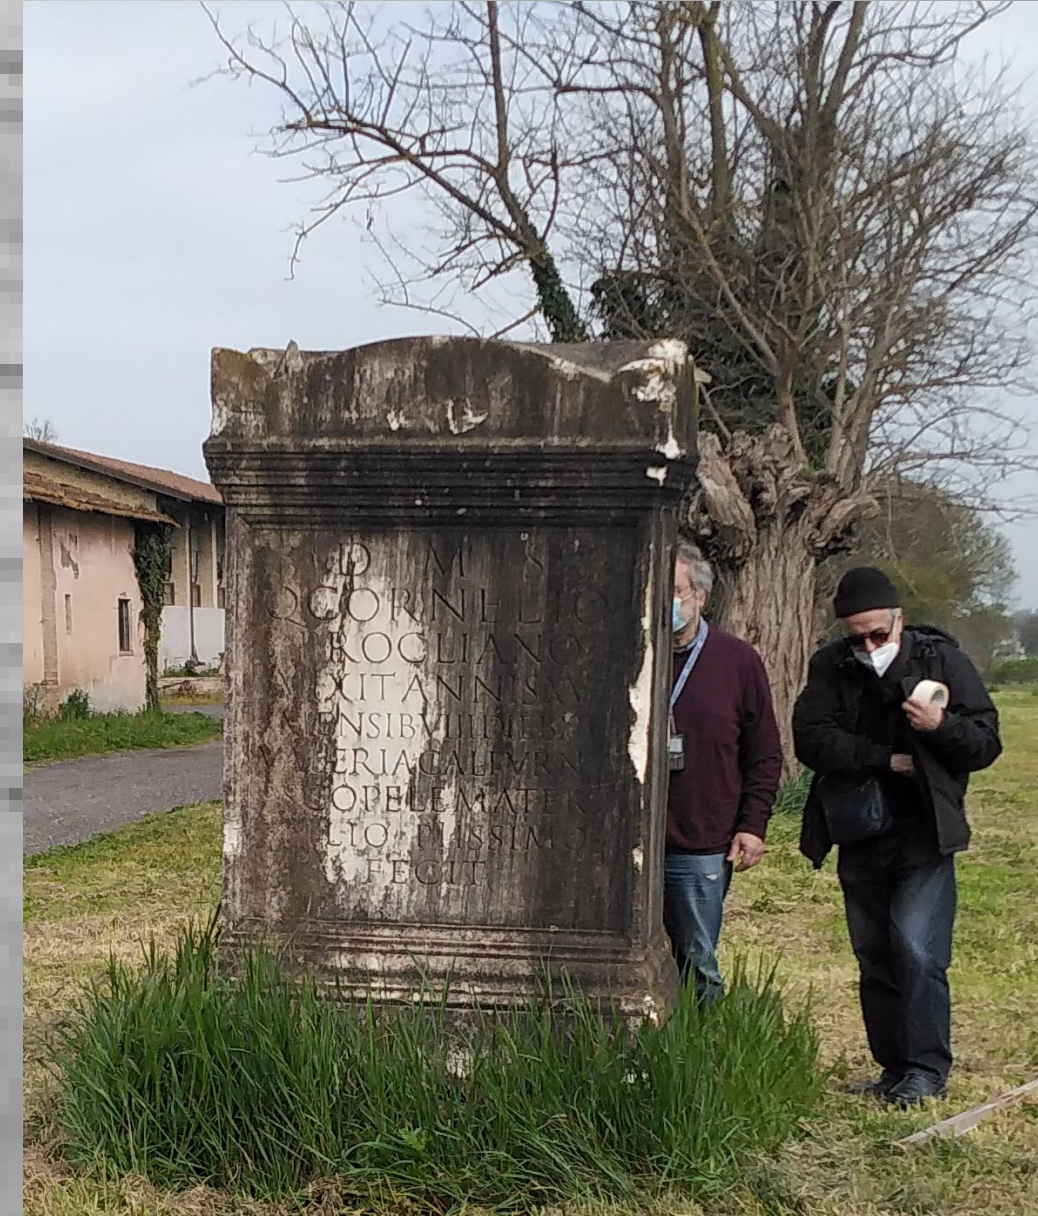
Fig. 1 - The Funus Cippus

Diagnostic analyses on a Funus Cippus (fig. 1), in precious white marble, located close to an ancient Roman consular road are here presented. The Cippus is in enough good conservative conditions but almost completely covered by a black patina; so, a conservative intervention was planned.

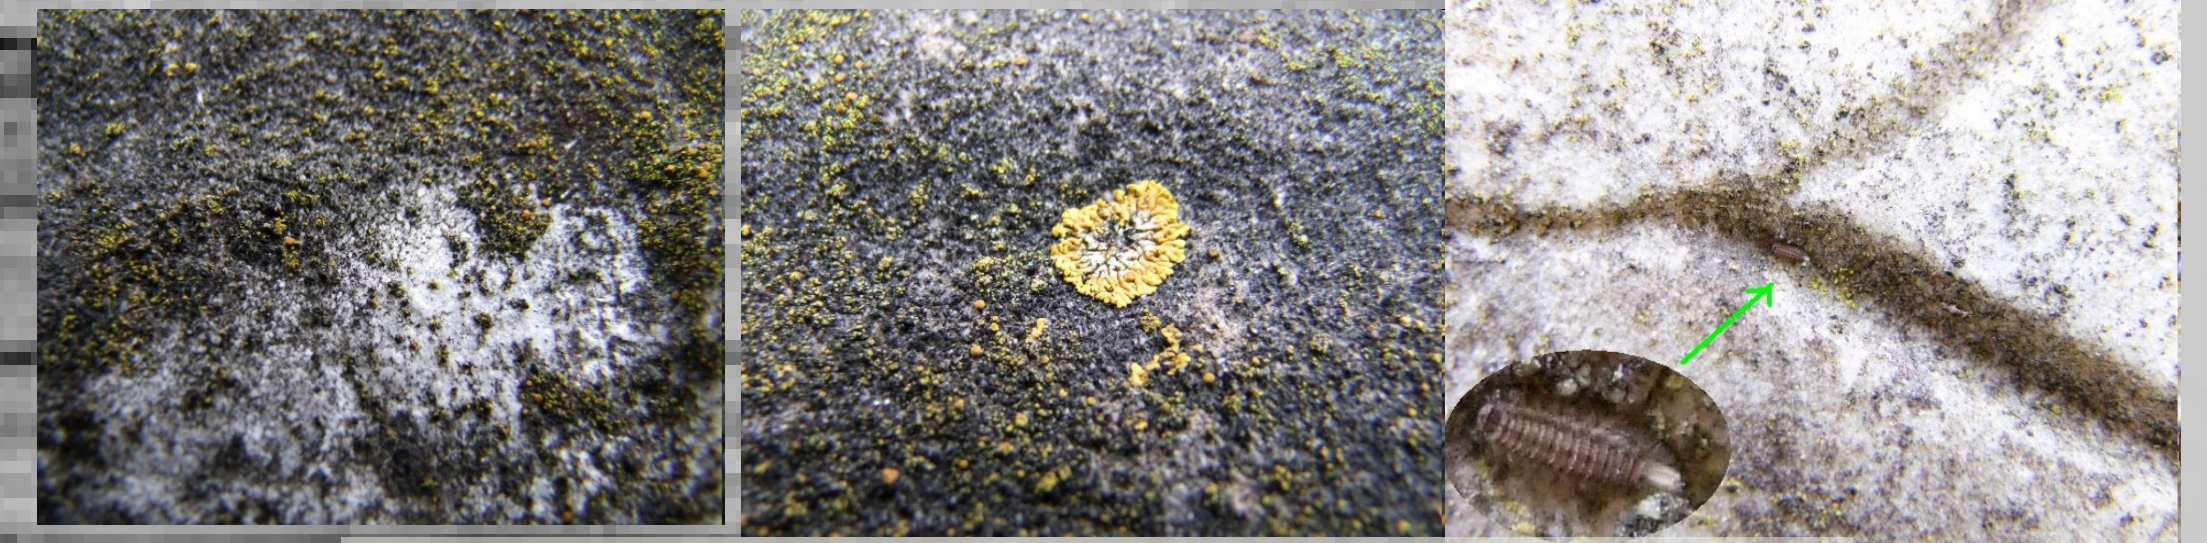
A first visual analysis shows that, as expected taking into account the location in open countryside, the patina is mainly of biological nature (fig. 2) In situ measures of the surface Temperature and Humidity were performed along vertical profiles on the 4 sides of the Cippus. The marble colour was evaluated on the uncovered by patina part of the Cippus and on the clean part of the fallen fragment using comparative Sikken strips and, from the relative codes, the L\*a\*b\* were obtained [2]. Samples of the patina were collected from the west (sample 1), south (sample 2) and east (sample 3) sides of the Cippus as well as a small fragments already fallen (sample 4).

Fig. 2 - Macrophotos of the patina covering the Cippus

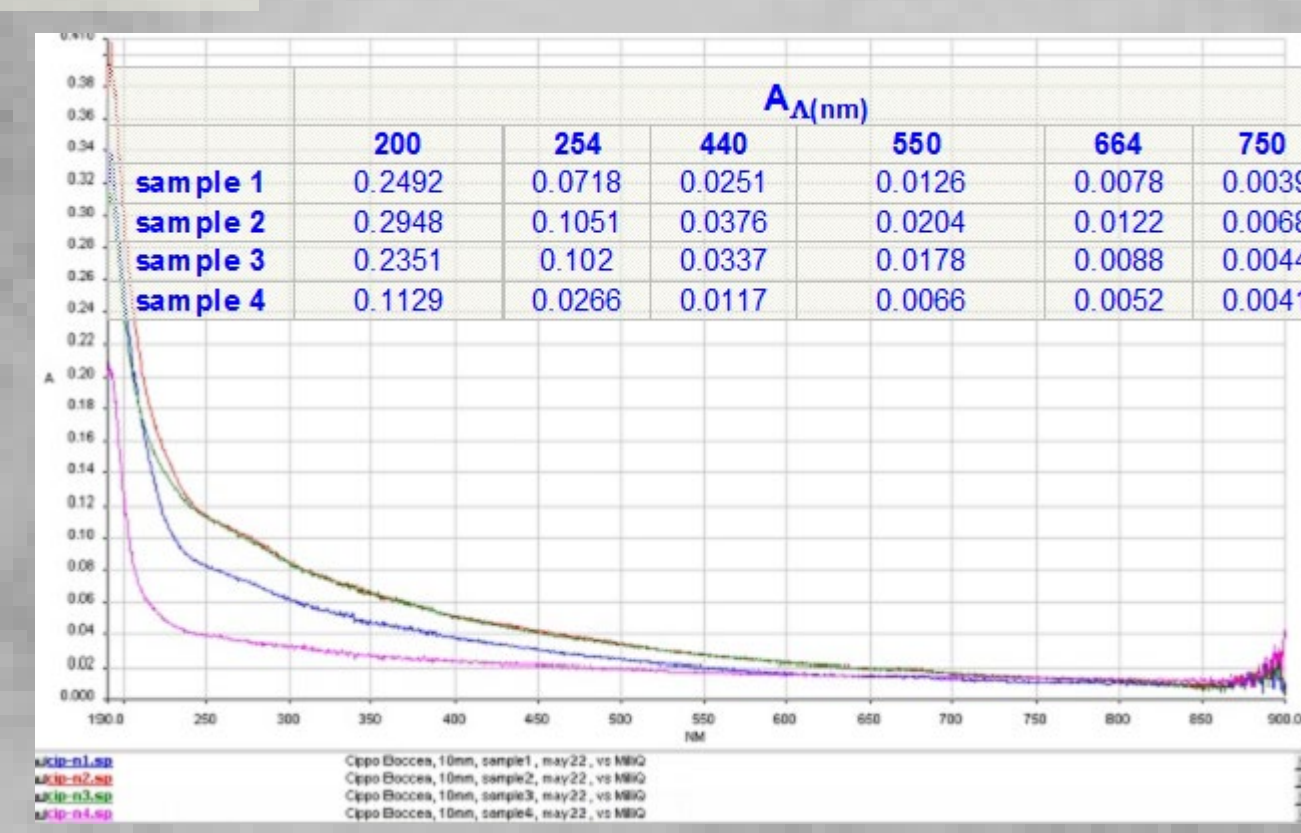
Fig. 7 - UV-vis spectra of the 4 samples. In Table Absorbance at different wavelength are considered as index of: nitrite and nitrate presence (200 nm), organic matter, (254 nm), chlorophyll a, b and carotenoids, (254 nm), red photosynthetic pigment (550 nm), chlorophyll A, (664 nm), turbidity, (750 nm)

UV-vis spectra (Fig. 7) confirm IC data about the lower content of nitrite and nitrate in the fragment. The expected lower content of organic matter and photosynthetic pigments is also evidenced.
