# Surface Degradation of Indoor Stonework in an Ancient Roman Church: XPS and SEM/EDS Investigation

The action of this work carried within the Italian Cultural Heritage framework was aimed at defining the main diagnostic aspects functional to the restoration of the interior of an ancient roman church - located near the centre of Rome along the river 'Tevere'.

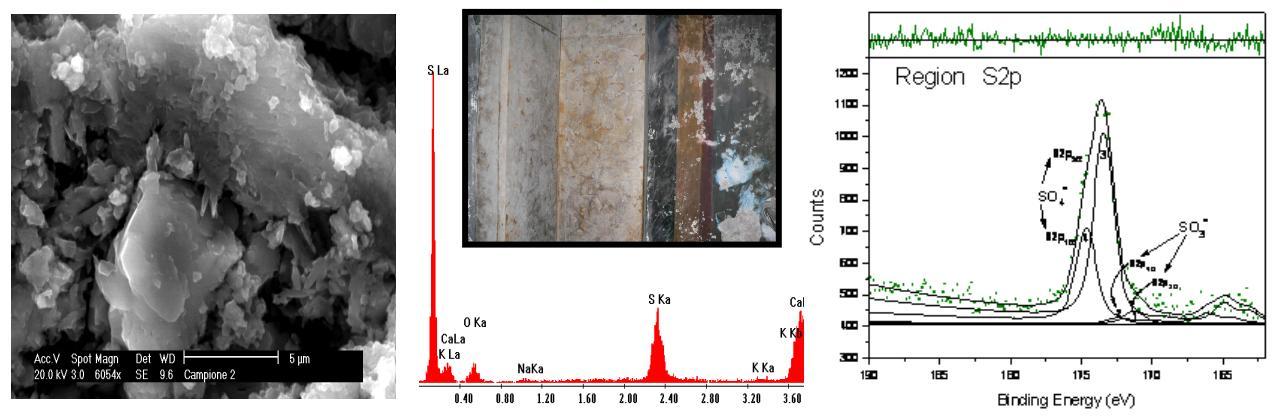
Figure 1; centre: one sampling zone and elemental analysis of the degraded surface product (*EDS*), right: S2p curve-fitted region (*XPS*), left: secondary electrons micrograph (*SEM*)

At the beginning of this diagnostic project, historical and artistic information of the church were merged with accurate 'in loco' examinations. Appropriate sampling modalities -in line with the international recommendations in the field- were then used for enabling 'ex-situ' analyses of the surface and sub-surface degradation products formed over the centuries onto structural and decorative materials inside the church - see figure 1.

The experimental results were elaborated and rationalized in relation to internal microclimates and locations as well as samples and techniques characteristics: see an example of combined analyses in figure 1. Based on these correlations and by also considering that carbonaceous components were steadily distributed on surfaces, the 'degraded compounds' could be grouped into three main classes.
