# Cluster Analysis to Discover Similarity Among Bricks for Restoration and Original Roman Age Bricks

A. Peduzzi, E. Dell'Aglio, G. Visco, M.P. Sammartino Department of Chemistry, Sapienza University of Rome, Rome, Italy

This study, started from a request of a restoration équipe during works on the roman building "Minerva Medica" (Rome), treats of survey on the conservation bricks used in the integrations. We obtained some samples of the original roman bricks and of those used for the integration. We looked for the better chromatic relationship between the two series of bricks in order to confirm the respect of the Cesare Brandi's restoration theory in the work of integration on the buildings. A spectrophotocolorimeter was used for the analyses and data, here presented in coordinates CIELab, have been treated by the cluster analysis.

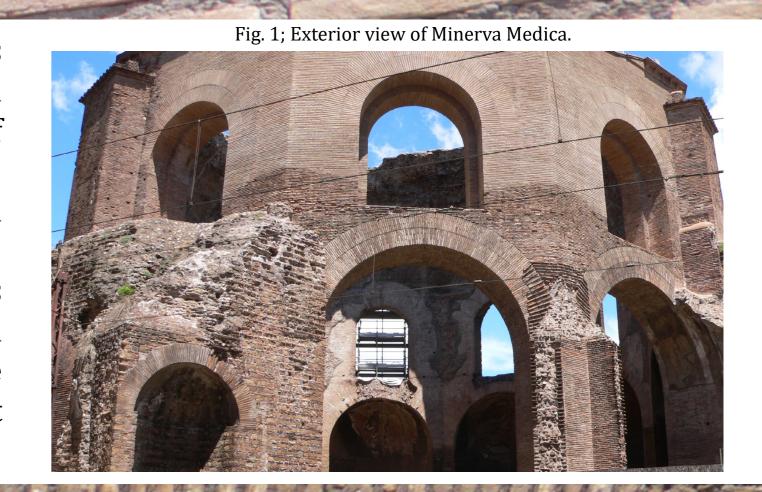
Minerva Medica (Fig.1) is a Roman building dating back to the fourth century BC, located in via Giolitti, that in this year has been object of a conservative restoration work, carried out on the behalf of the Soprintendenza Speciale per i Beni Archeologici di Roma, to reconstruct missing parts of the monument [1]. Basing on the Cesare Brandi's restoration theory, the integration of such parts is allowed but must be done with visually similar but recognizable materials [2].

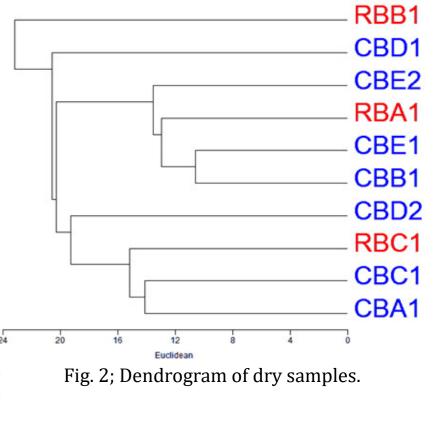
The tables and the respective dendrograms summarize the results obtained from the cluster analysis for dry samples (Tab. 1 and Fig. 1) and for the wet ones (Tab. 2 and Fig. 2). The original roman bricks and integration bricks are reported in red and blue respectively.

As it regards the bricks in dry condition (Tab. 1 and fig. 2), a chromatic similarity between the CBB1, CBE1 and the roman RBA1 is evidenced while the colour of CBC1 and CBA1 resulted more similar to the one of RBC1. Even if CBE1 and CBE2 came from the same site, they are not in the same group, maybe because of the non homogeneity in colour of the single bricks. CBD1 and CBD2 have the same problem that in this case must be imputed to the second brick that presents a rosy compact ring that lightens surface. No one of the integration bricks seems to be suitable for integration of bricks like the one RBB1 (crimson red).

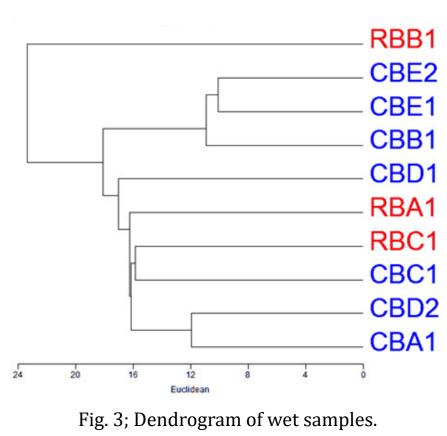
Passing to wet condition, a decrease of L\* and an increase of a\* and b\* occur for all the bricks. CBE1 and CBE2 lose the dissimilarity seen on dry surfaces. The distance between CBD1 and CBD2 increases because of the rosy ring that, being impermeable, doesn't change colour under the effect of water. In this condition CBC1 results perfect to integrate the roman RBC1. Finally, also in wet conditions there are no conservation brick suitable to integrate RBB1 (Tab. 2 and fig. 3).
